# TEST REPORT

Sample Name: Lithium battery

Model No.: LV51314H

Test Item: IP66

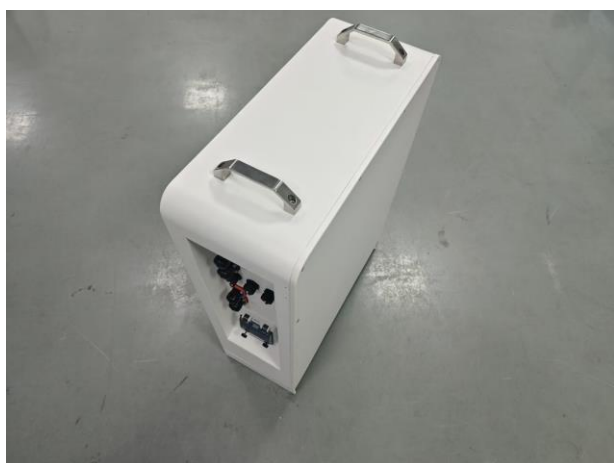
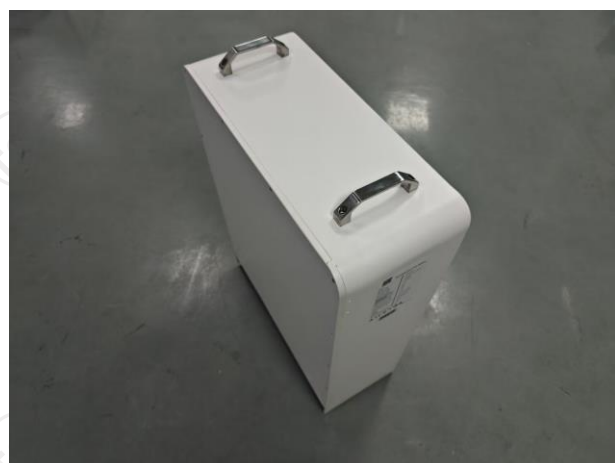
Before the test, the surface of the sample is not damaged, there is no abnormality.

Pre-test sample

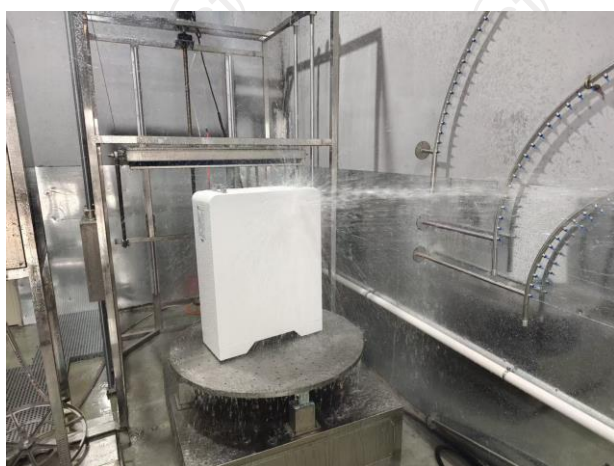
- a) Nozzle inner diameter: 12.5mm;
- b) Water flow rate :100L/min;
- c) Sprinkler distance sample: 2.5m ~ 3m;
- d) Test time: 3 min;

Under Testing- IPX6

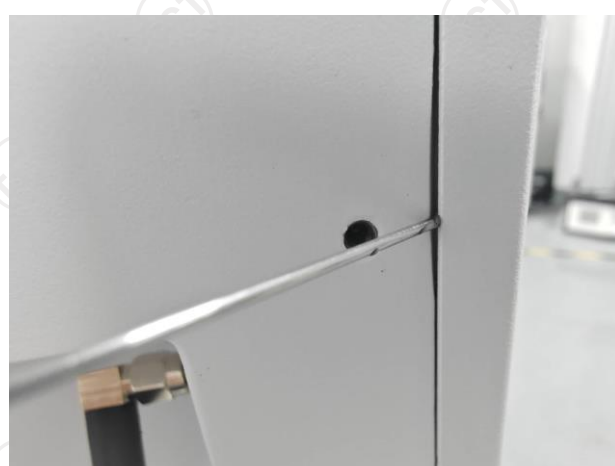
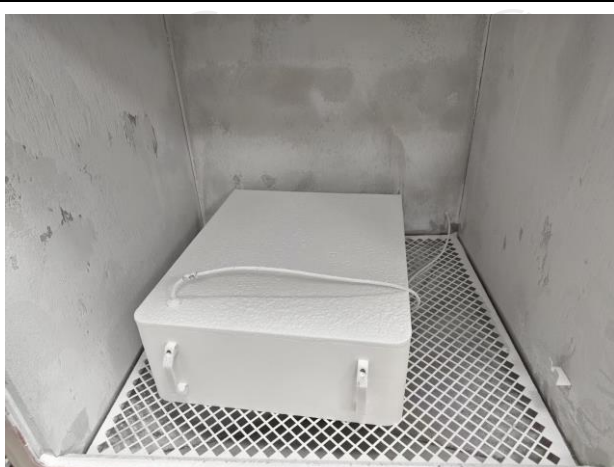
- Using a test probe with a diameter of 1 mm, apply a force of 1N to probe the gap part of the sample;
- Put the sample under negative pressure, pressure difference < 2kpa, and the pumping volume per hour is less than 40 times the shell volume, put it in a dust test chamber containing 2kg/m<sup>3</sup> talc for continuous testing for 8 hours.

Under Testing- IP6X

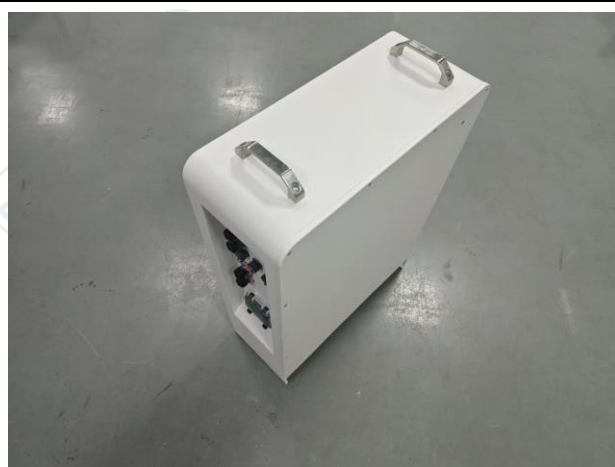
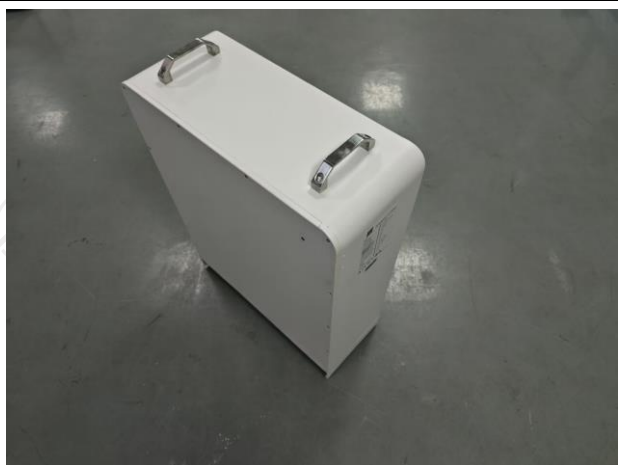
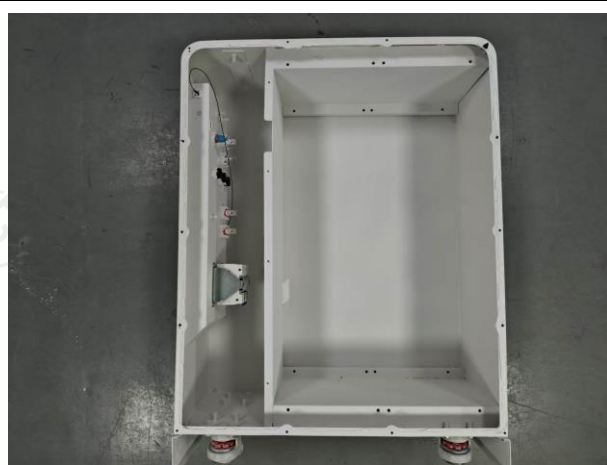
| Sample No. | Test Item | Test Results | Judgement Result |
|---|---|---|---|
| TS251024D00101 | IP66 | The test probe cannot penetrate into the sample;<br>After the test, no dust enters the inside of the sample, no water enters the inside of the sample. | PASS |

Post-test sample
